Manhole Inspection Summary

Manhole # S49E__017MH

Insp Date: **3/9/09 1:47 PM**

Location Address: **2600 E BALTIMORE-FAIRMONT-ALLEY** Cross Street: **N LUZERNE AV**

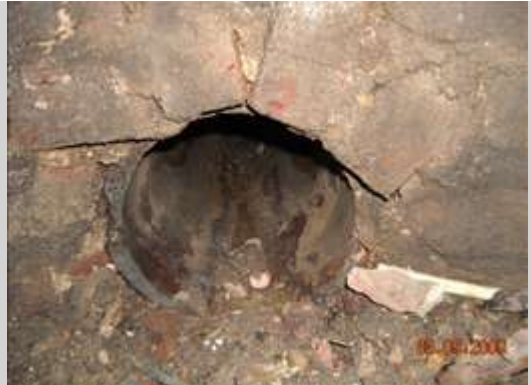
12 O'Clock Outflow

8 in. Circular Gravity Sewer
Pipe Out @ 12 O'Clock

Pipe Height: **8.4** (in.) Rod and Bar (Angled)

Pipe Material: **Clay** ☐ Pipe Lined

Infiltration: **None** Pipe Seal Cond: **Sound**
